# **WATER QUALITY TRADING PLAN**

**VILLAGE OF SLINGER  
WASHINGTON COUNTY, WISCONSIN  
DECEMBER 2019**

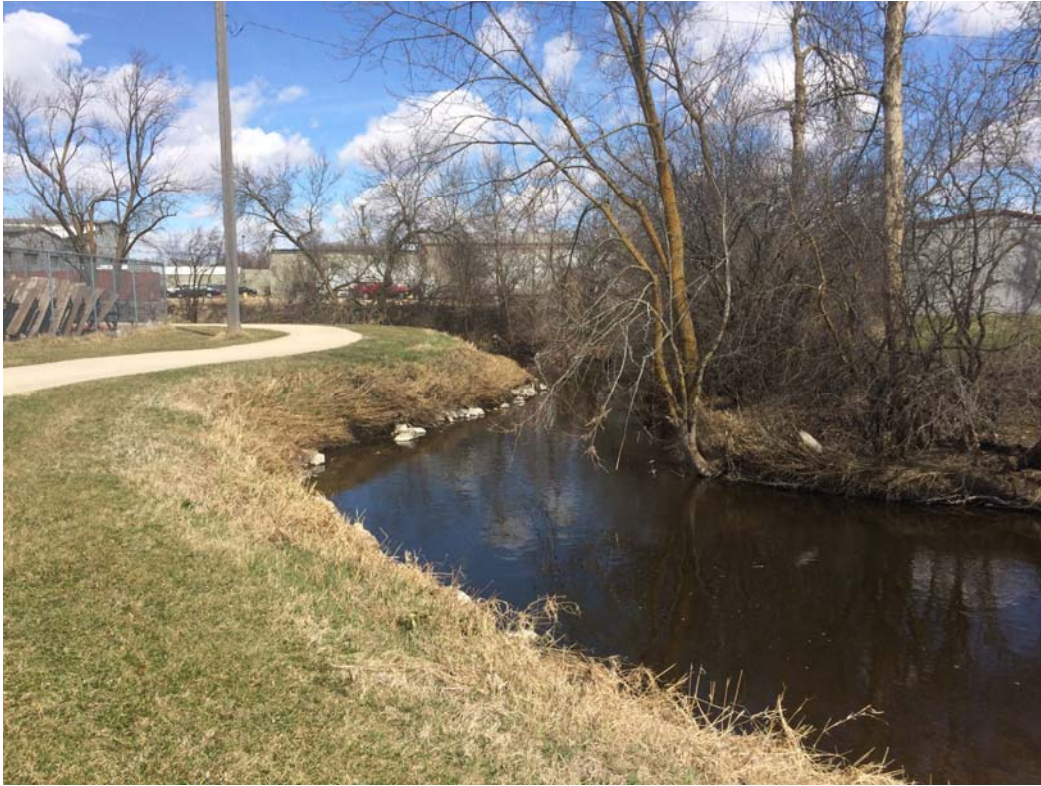
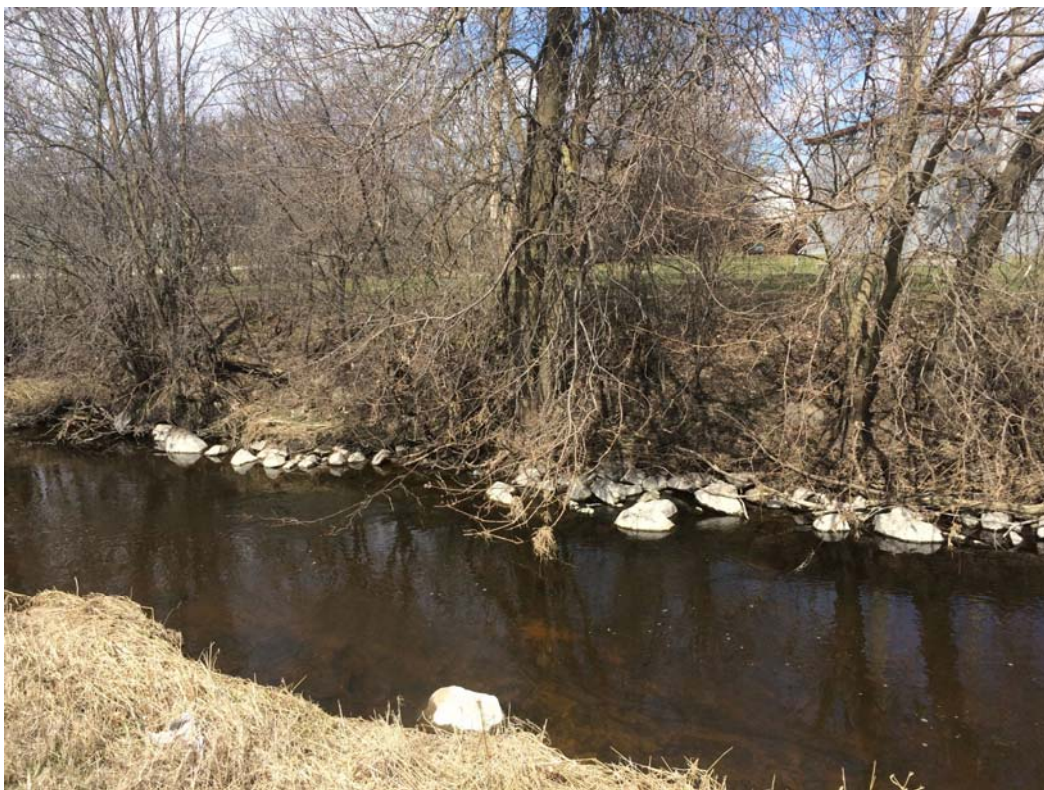
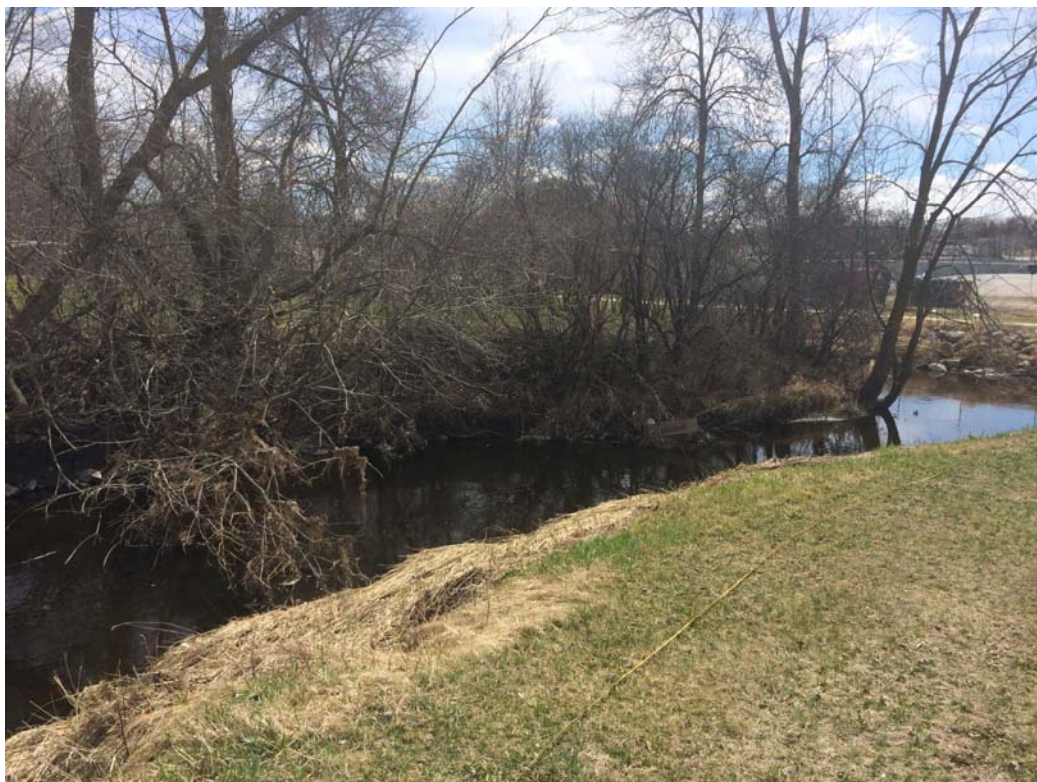
South Bank (SB) 1 and North Bank (NB) 1 are the 220 ft. sections directly west of Grant St. The average streambank height of SB1 is 9.5 ft., and the average streambank height of NB1 is 13.5 ft. The soil TP concentration is 680 ppm and 720 ppm for SB1 and NB1, respectively. Figures 3-5 show various perspectives of the north and south bank for reference. There are three active storm water outlets in this section of the river which contribute storm water flows directly to the Rubicon River. Based on the location of these outlets, no direct scouring of the streambank was assumed to occur as a result of storm water flows.

The southern bank is vegetated but has a fairly steep slope down to the water level. Through the vegetated cover there were signs of soil loss throughout the measured streambank height, but the erodible bank height was divided by two to account for the stabilization provided by the existing vegetation. The lateral recession rate was estimated to be 0.05 ft./year per guidance included in the NRCS Streambank Erosion Estimator. The recession rate was determined to be "slight" due to some patches of bare bank, some rills, but no vegetative overhang or exposed tree roots.

The northern bank is covered with trees and brush but the soil is predominantly bare. There are exposed tree roots and other visual signs of erosion. For this reason, the entire average bank height was considered erodible, and the lateral recession rate was assumed to be 0.20 ft./year, or "moderate".

**Figure 3.** SB1/NB1 Streambank Image 1

**Figure 4.** SB1/NB1 Streambank Image 2

**Figure 5. SB1/NB1 Streambank Image 3**

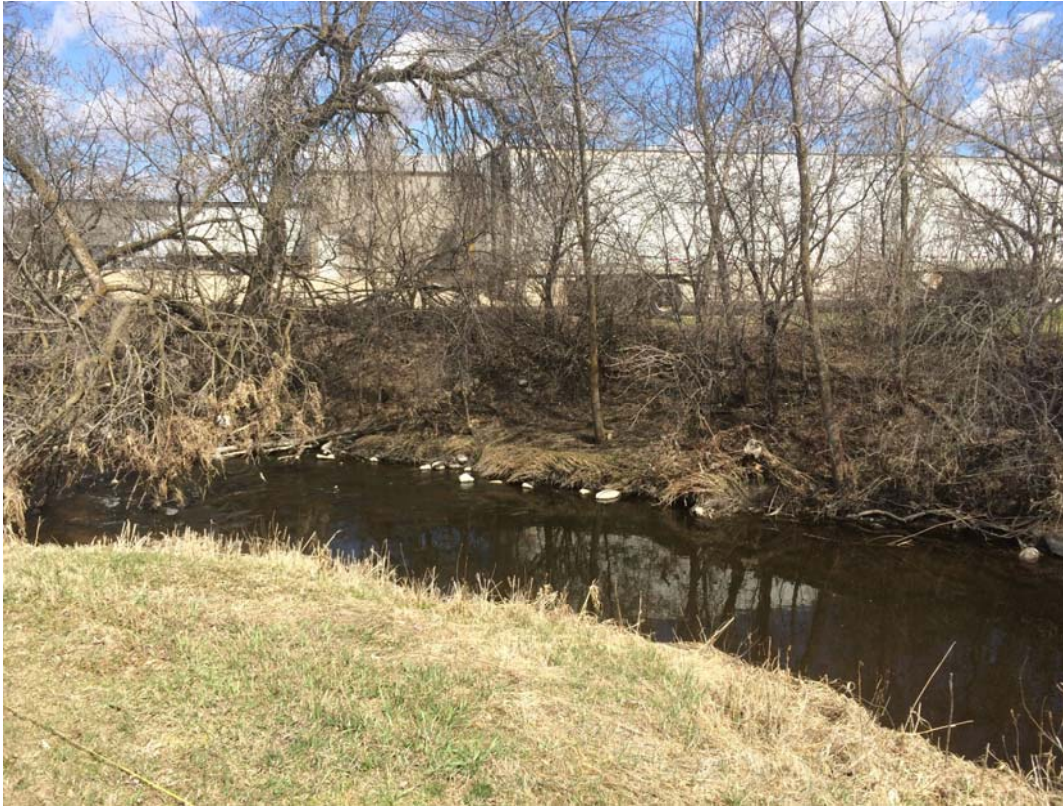
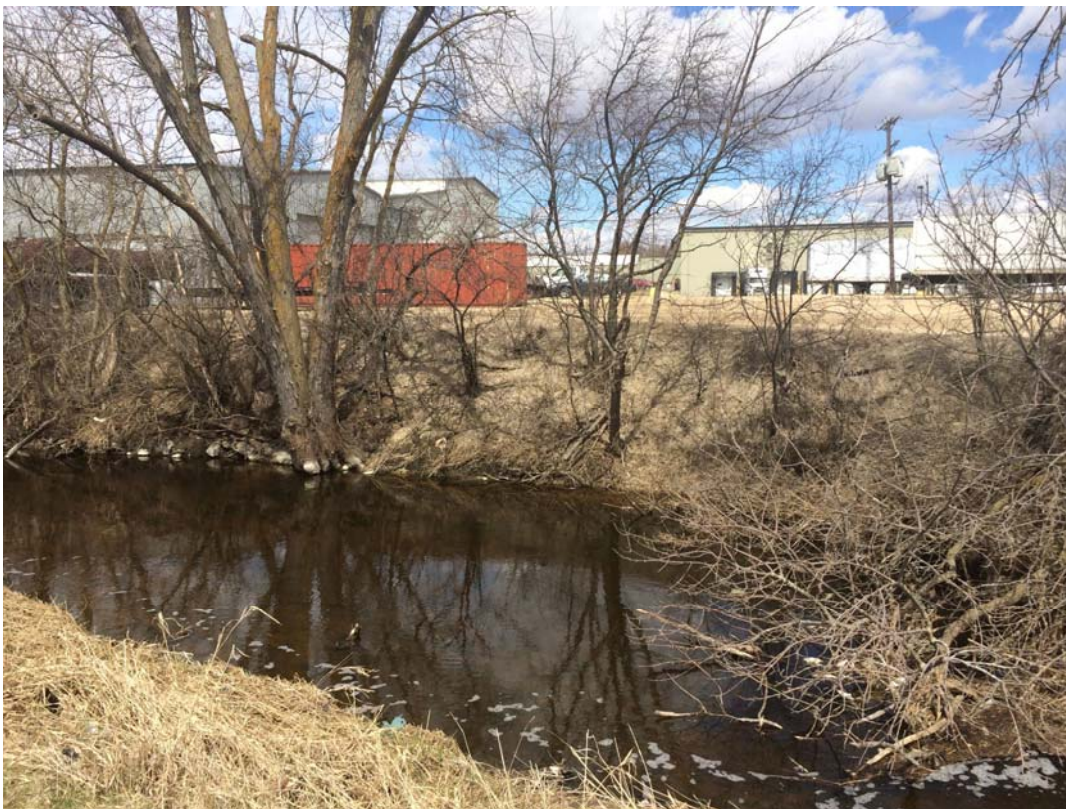
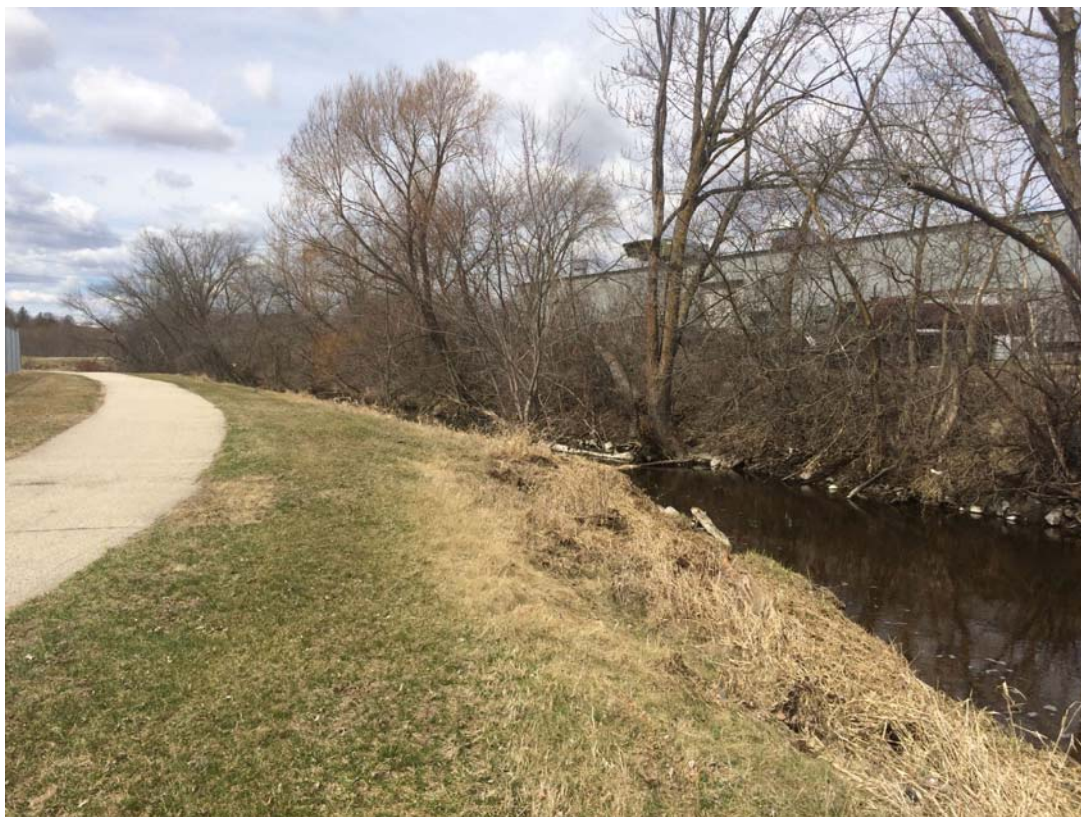
South Bank 2 and North Bank 2 are the 220 ft. sections adjacent to businesses that exist north of the site, west of SB1 and NB1. The average streambank height of SB2 is 13.0 ft., and the average streambank height of NB2 is 13.3 ft. The soil TP concentration is 590 ppm and 540 ppm for SB2 and NB2, respectively. Figures 6-8 show various perspectives of the north and south bank for reference.

The southern bank is similarly vegetated to SB1 but has a gentler slope to the water level. Through the vegetated cover, there were still signs of soil loss, so the erodible bank height was again divided by two to account for the stabilization provided by the existing vegetation. The lateral recession rate was estimated to be 0.05 ft./year.

The northern bank has longer sections without trees and brush and the soil is predominantly bare. The erosion in this section was observed to be greater than NB1, with exposed tree roots, trees falling into the river, and notable signs of erosion. Again, the entire average bank height was considered erodible, and the lateral recession rate was assumed to be 0.40 ft./year, or “severe”. Erosion in this section is assumed to occur by scouring from the stream during high flows as well as by overland flow, freezing, and thawing across the entire bank. There was gravel from the parking lots of the adjacent businesses in several segments of NB2, showing that plowing and runoff from the adjacent parking lot may be contributing to the deterioration of the streambank. For this reason, measures beyond the stabilization of the section of the streambank may be required to address all causes of erosion for this section of the streambank. These measures may include the City working with the owners of the businesses adjacent to the streambank to alter their methods of snow plowing during winter months to eliminate gravel and soil being pushed towards the stream location. If working with the business owners is not effective, the Village of Slinger may consider adding a barrier along the property line of sections of the streambank most susceptible to receiving gravel and soil from the adjacent parking lot areas.

**Figure 6.** SB2/NB2 Streambank Image 1

**Figure 7.** SB2/NB2 Streambank Image 2

**Figure 8. SB2/NB2 Streambank Image 3**

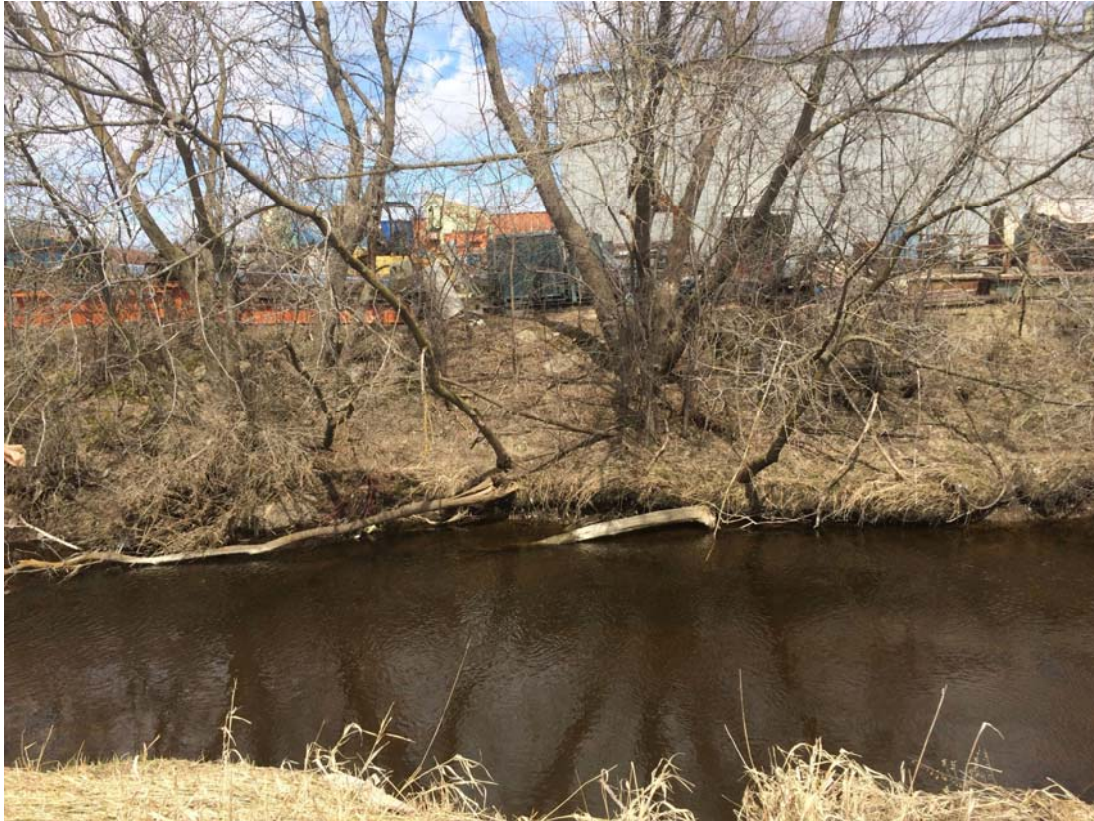
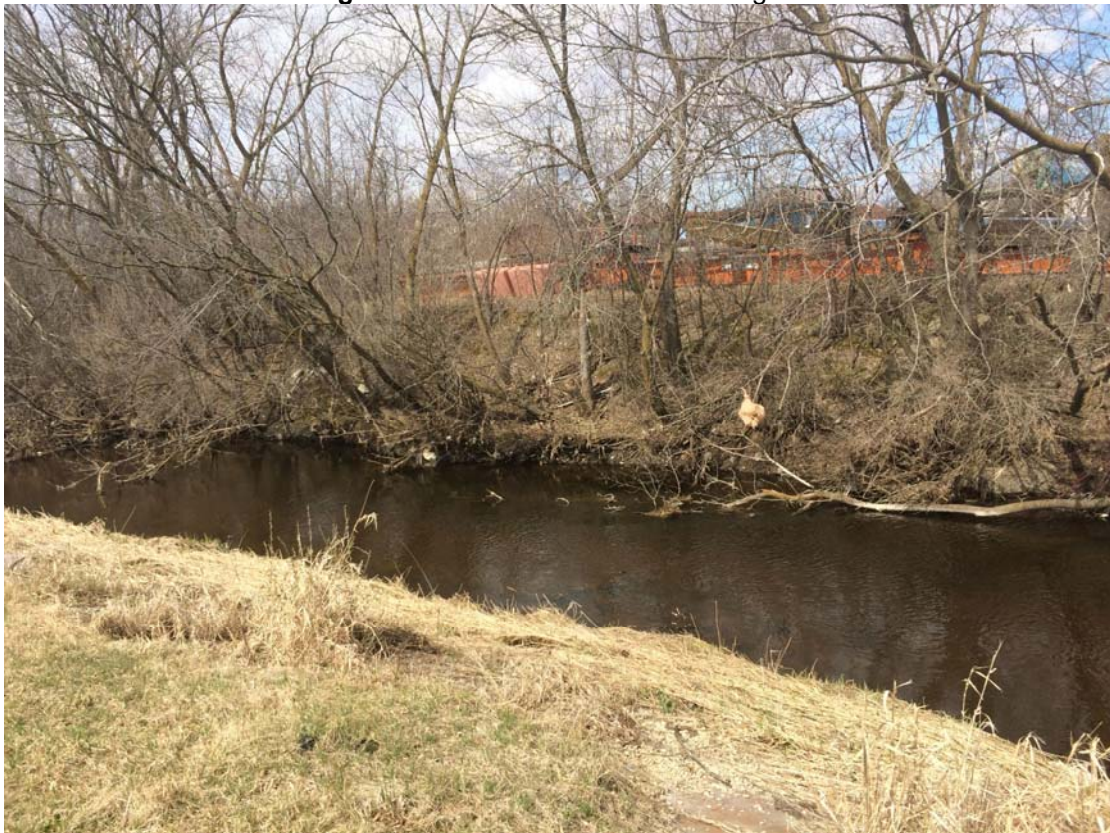
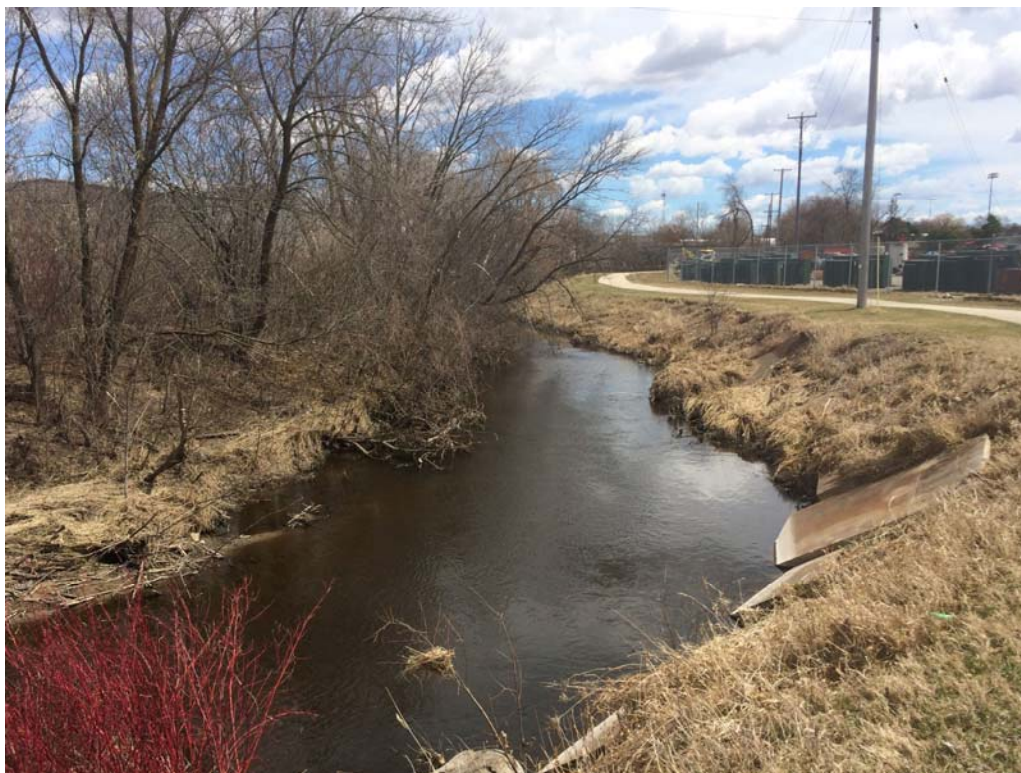
South Bank 3 and North Bank 3 are the 220 ft. sections adjacent to businesses that exist north of the site, west of SB2 and NB2. The average streambank height of SB3 is 16.0 ft., and the average streambank height of NB3 is 12.5 ft. The soil TP concentration is 320 ppm and 440 ppm for SB3 and NB3, respectively. Figures 9-11 show various perspectives of the north and south bank for reference.

The southern bank is qualitatively similar to SB2. The erodible bank height was again divided by two to account for the stabilization provided by the existing vegetation. The lateral recession rate was estimated to be 0.05 ft./year. The northern bank is also very similar to the adjacent section NB2. The lateral recession rate was again assumed to be 0.40 ft./year, or “severe”, with the entire bank height showing signs of erosion.

In some areas of the southern bank in SB2-SB4 there are concrete slabs and steel road plates resting on the streambank. The City staff commented that these were placed in the early 1990s in order to help stabilize the streambank. These structures will be evaluated in future project planning to determine the best approach.

**Figure 9.** SB3/NB3 Streambank Image 1

**Figure 10.** SB3/NB3 Streambank Image 2

**Figure 11. SB3/NB3 Streambank Image 3**

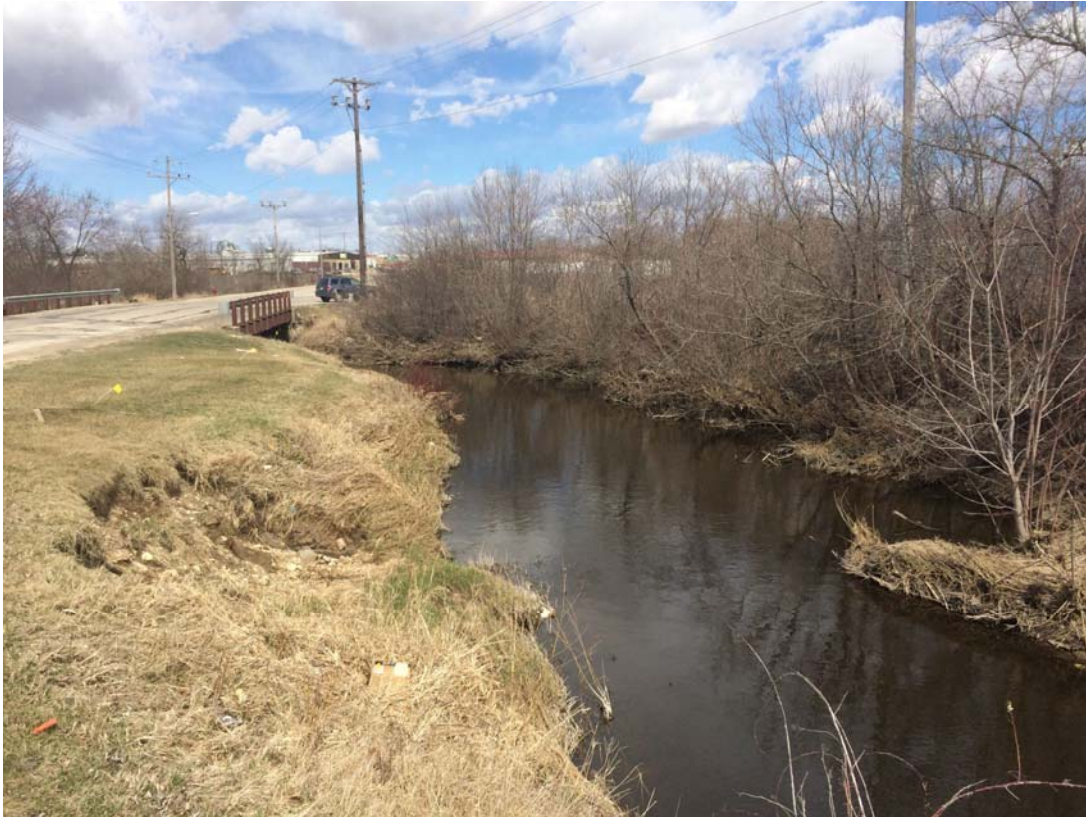
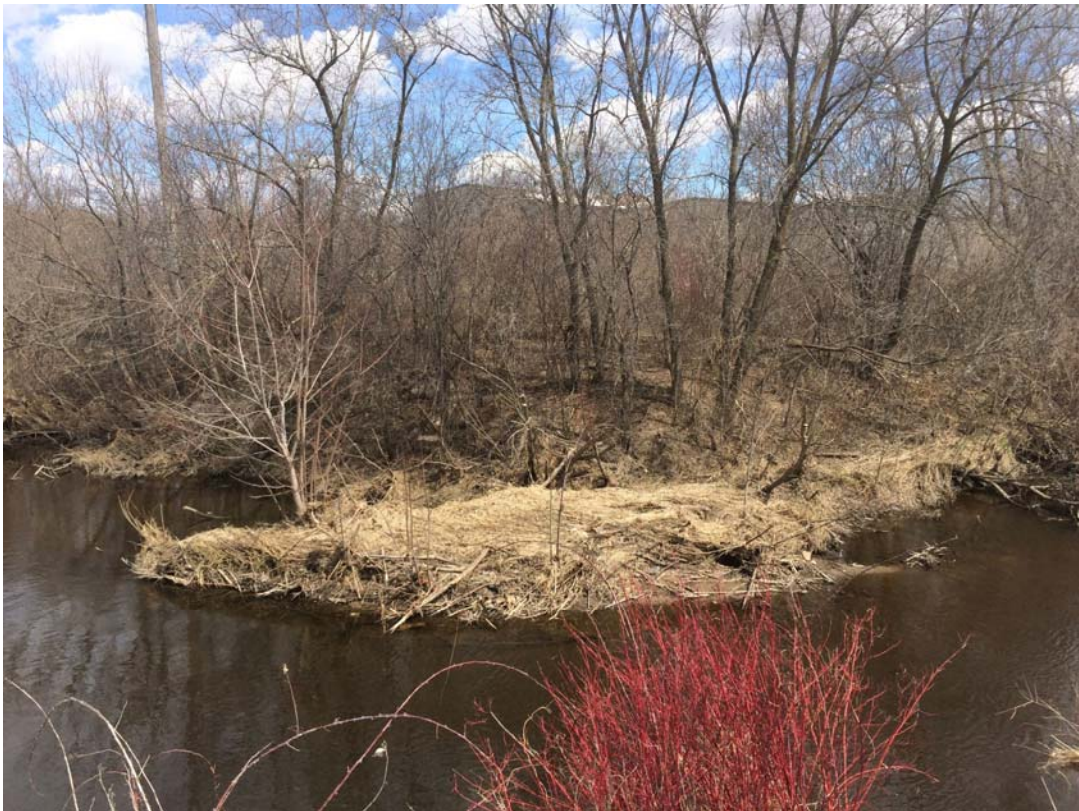
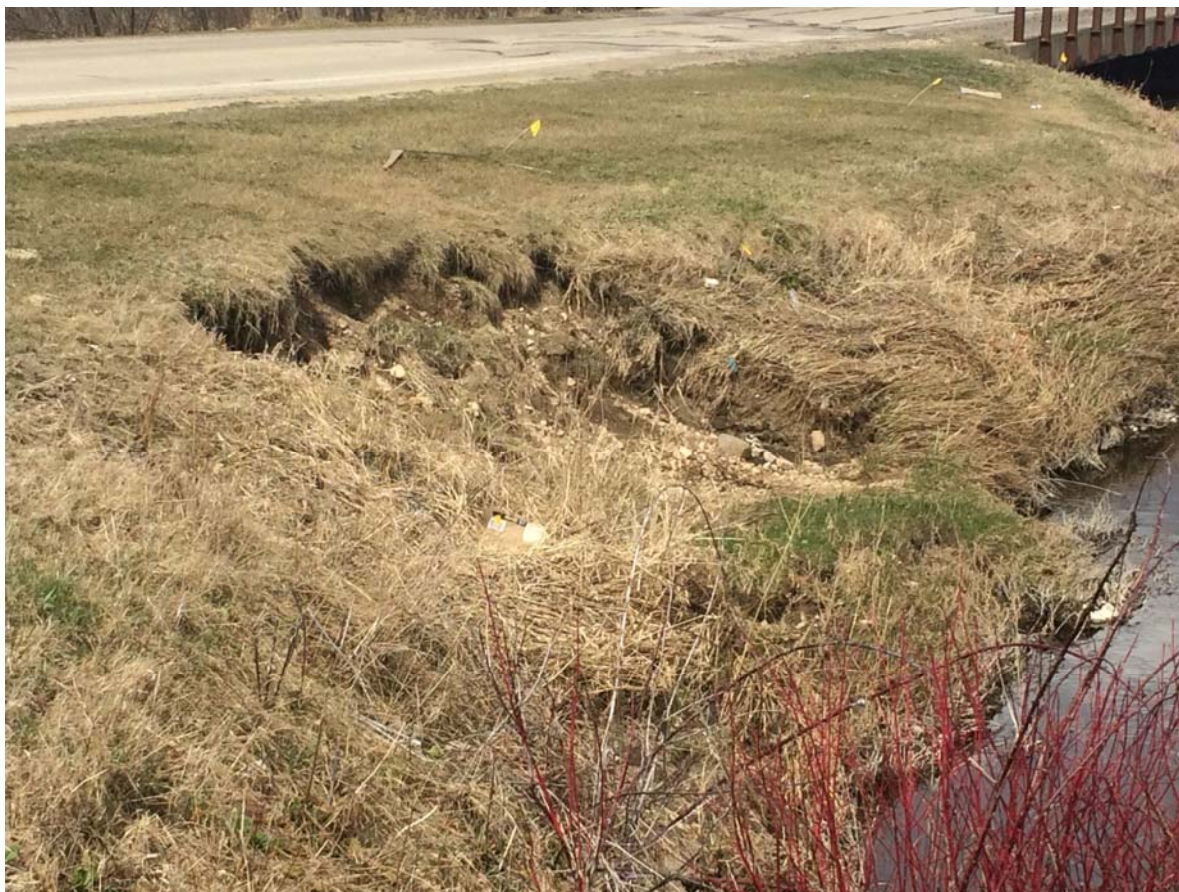
South Bank 4 and North Bank 4 are the 215 ft. sections directly east of N. Wacker Dr. The average streambank height of SB4 is 13.2 ft., and the average streambank height of NB4 is 16.5 ft. The soil TP concentration is 420 ppm and 610 ppm for SB4 and NB4, respectively. Figures 12-14 show various perspectives of the north and south bank for reference.

The southern bank is similarly vegetated to past sections of the southern bank; however, there is a concentrated area of bare, eroded soil shown below in Figures 12 and 14. The City of Hartford may want to work with the Village during design and construction of streambank stabilization measures to address this specific area of the southern bank. The erodible bank height was again divided by two to account for the stabilization provided by the existing vegetation. The lateral recession rate was increased to 0.1 ft./year to account for the disrupted area of the bank as well as generally steeper slopes to the river location.

The northern bank section east of N. Wacker Dr. had a greater concentration of brush than sections NB2 and NB3. Also, there is a portion of the northern bank that serves as a depositional area in the eastern half NB4. For these reasons, the proposed length of streambank stabilization measures was reduced from 220 ft. to 130 ft per recommendation of WDNR staff. The 130-foot portion that the Village is planning to stabilize is in the northwestern portion of NB4, extending from the bridge southeast to the start of the depositional area. A lateral recession rate of 0.20 ft./year was assumed for this section of the bank as it is qualitatively similar to NB1. An erodible bank height of 12.4 ft. was assumed for the 130-foot portion of the streambank which is 75% of the average measured bank height.

**Figure 12.** SB4/NB4 Streambank Image 1

**Figure 13.** SB4/NB4 Streambank Image 2

Figure 14. SB4/NB4 Streambank Image 3

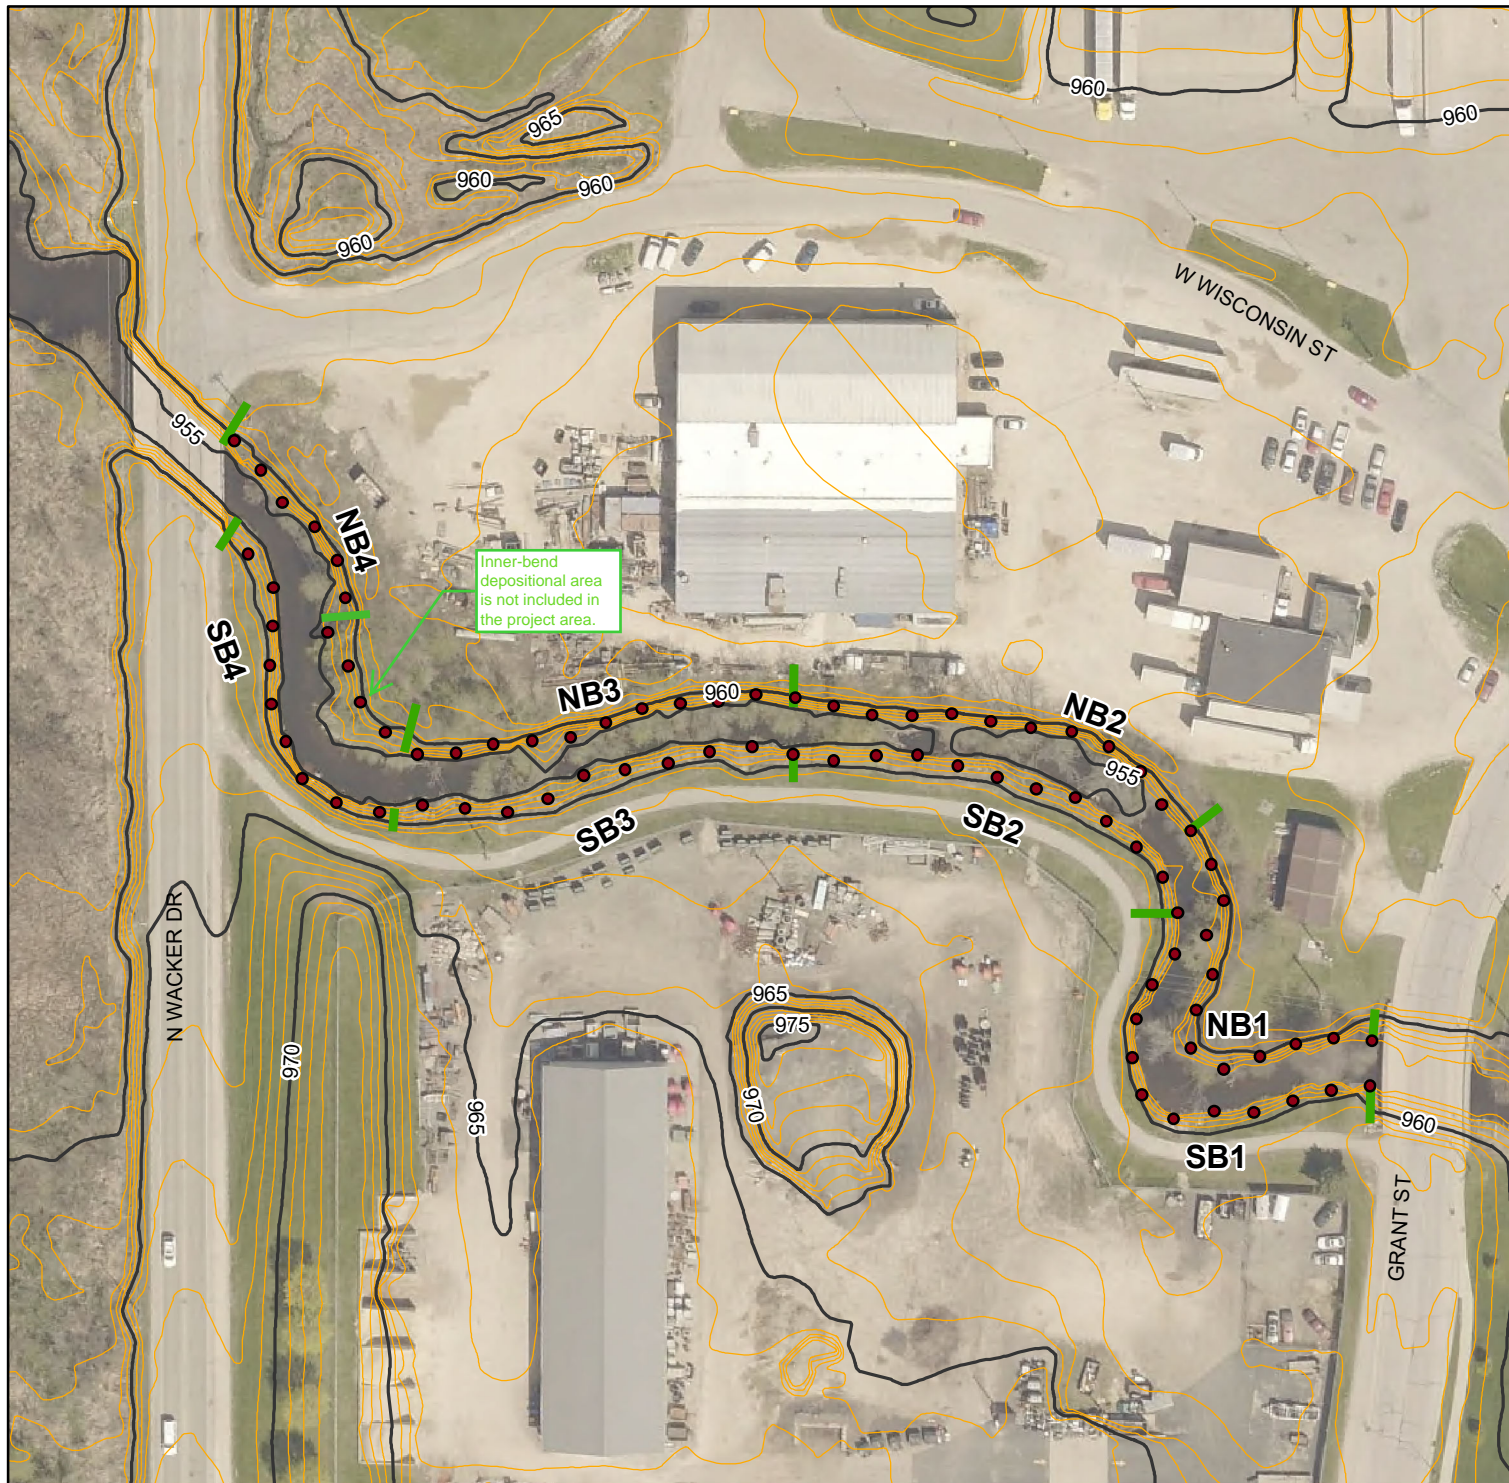
**Rubicon River Streambank  
Stabilization Site**  
**City of Hartford, WI**

A preliminary survey of streambanks in the area showed that there were several areas in the City of Hartford that could benefit from conservation measures. A preliminary analysis of three of these sites was conducted using the NRCS Streambank Erosion Estimator tool. The results of the analysis showed that one specific section of the Rubicon River adjacent to the City of Hartford DPW showed a potential for significant credit generation. The Village focused their efforts at this site as the primary credit generator for their compliance efforts. An exhibit of the site is include in Appendix A for reference.
